Name of Dam: Johns Creek No. 3
Location: Craig County, State of Virginia
Inventory Number: VA 04503

PHASE I INSPECTION REPORT NATIONAL DAM SAFETY PROGRAM

PREPARED BY
MICHAEL BAKER, JR., INC.
BEAVER, PENNSYLVANIA 15009

AUGUST 1979

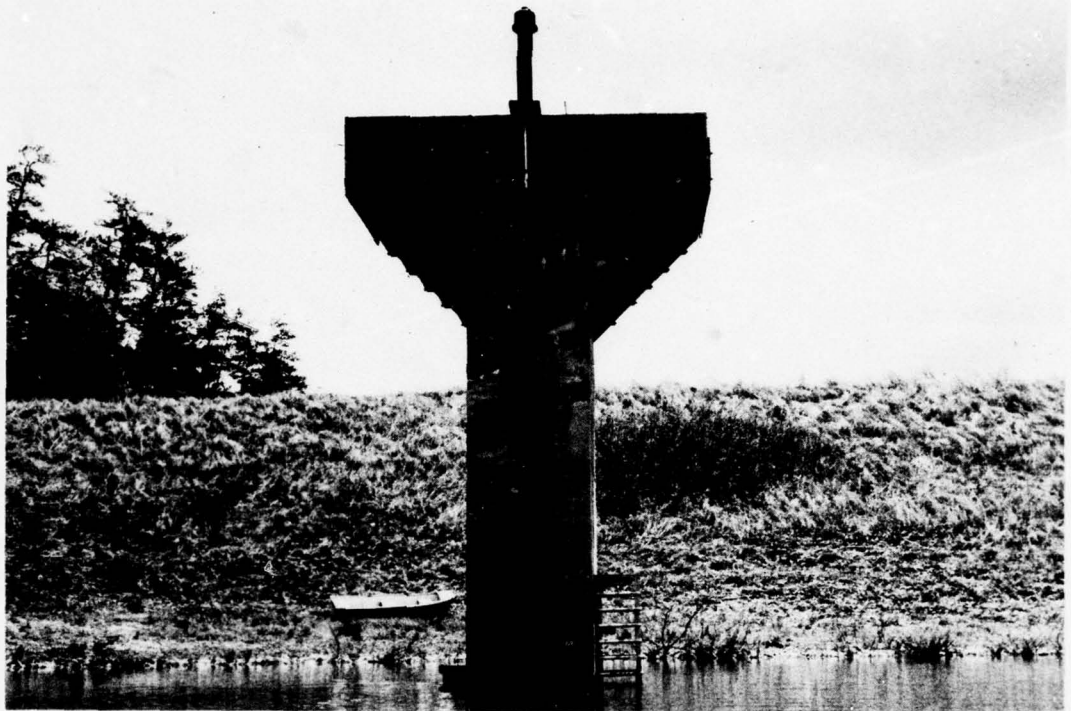
PHOTO 1. Upstream Embankment and Riser with Lift Pedestal and Stem for Reservoir Drain

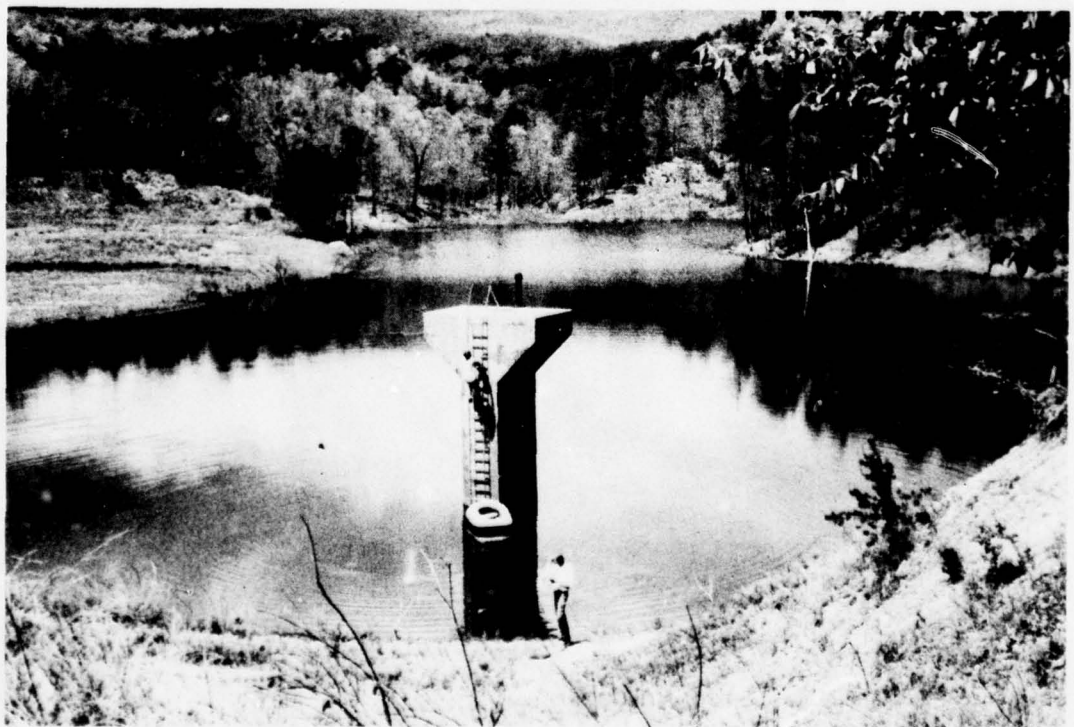
PHOTO 2. Reservoir, Riser and Erosion on Left Abutment

- 3.2 Evaluation: The cracks in the riser noted on the visual inspection check list should be cleaned and repaired. The trees on the embankment, at the edge of the water, and beside the outlet pipe should be removed. The eroded area on the left abutment should be seeded, after grading, to remove the root mantle overhang. Although the rodent holes are not considered detrimental to the safety of the dam, the burrows should be excavated and backfilled as part of normal maintenance operations.

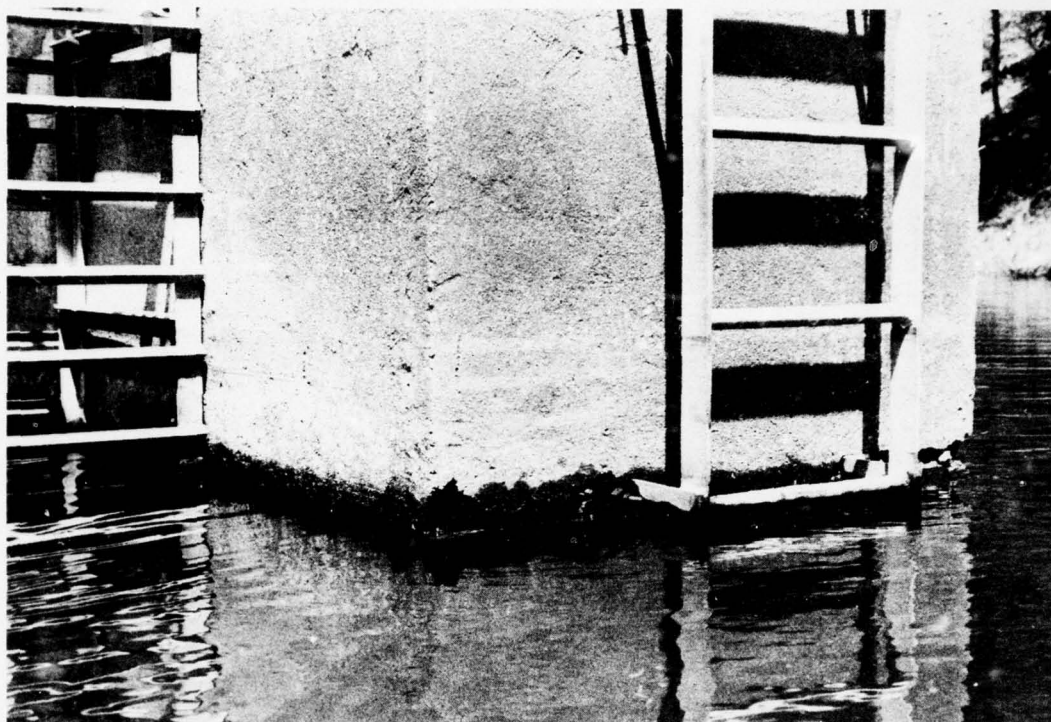
- 3.1.3 Appurtenant Structures: Significant cracking and spalling (see Photo 3) was found on the riser at the normal pool waterline. This cracking and spalling is apparently the result of freeze-thaw conditions along with the possibility of weak concrete. The cracks do not extend through the wall of the riser and are not considered to threaten the stability of the riser at their present condition. However, they should be repaired with an epoxy concrete to prevent further deterioration. Except for the condition of the riser, no serious deficiencies were found in any of the appurtenant structures.

The spalling and cracking in the concrete riser at normal pool level is not considered to seriously threaten the stability of the structure. However, further deterioration will occur if this condition is not corrected.

PHOTO 3. Close-up View of Riser Showing Deterioration of Concrete at Water Level

- 7.2 Recommended Remedial Measures: It is recommended that the spalling and cracking on the riser be repaired with an epoxy concrete as part of general maintenance. Although the repairs are not considered urgent, they should be completed within a year to prevent more serious deterioration.

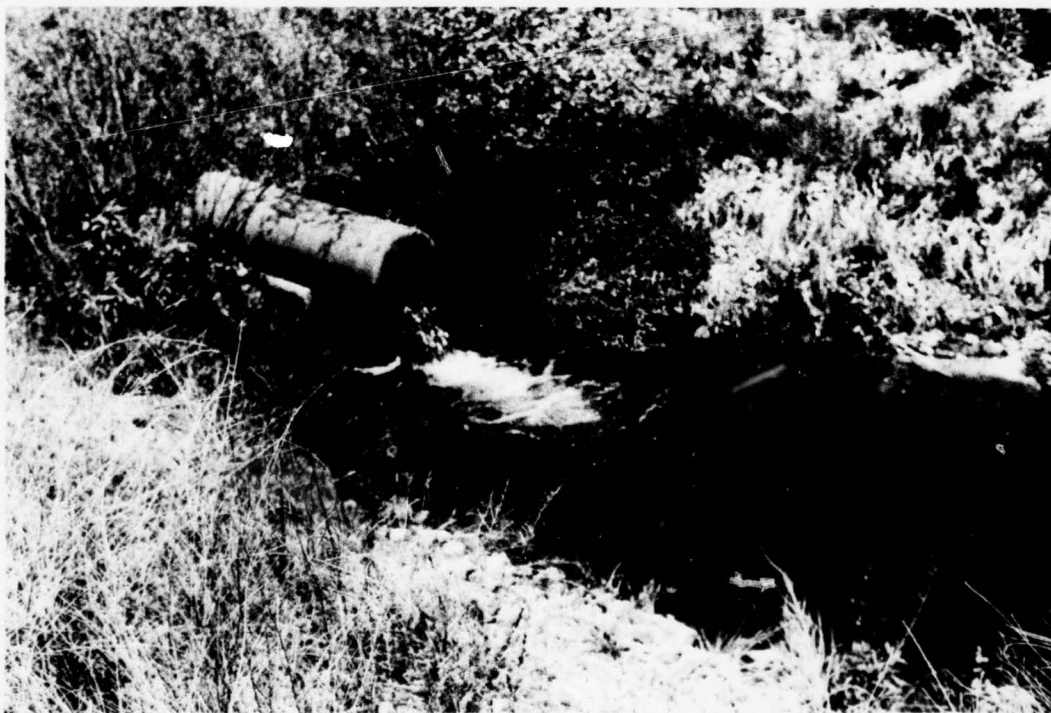
3.1.2 Dam: No obvious signs of embankment instability were noted. The alignment and slopes approximate the as-built drawings. There was some clear seepage (+0.5 g.p.m.) noted at the right of the outlet pipe, but it was probably coming from the rock toe drain. The small wet area to the left of the outlet pipe (near the abutment) does not indicate a potential stability problem, as its source may be a spring.

PHOTO 4. Outlet Pipe and Stilling Basin

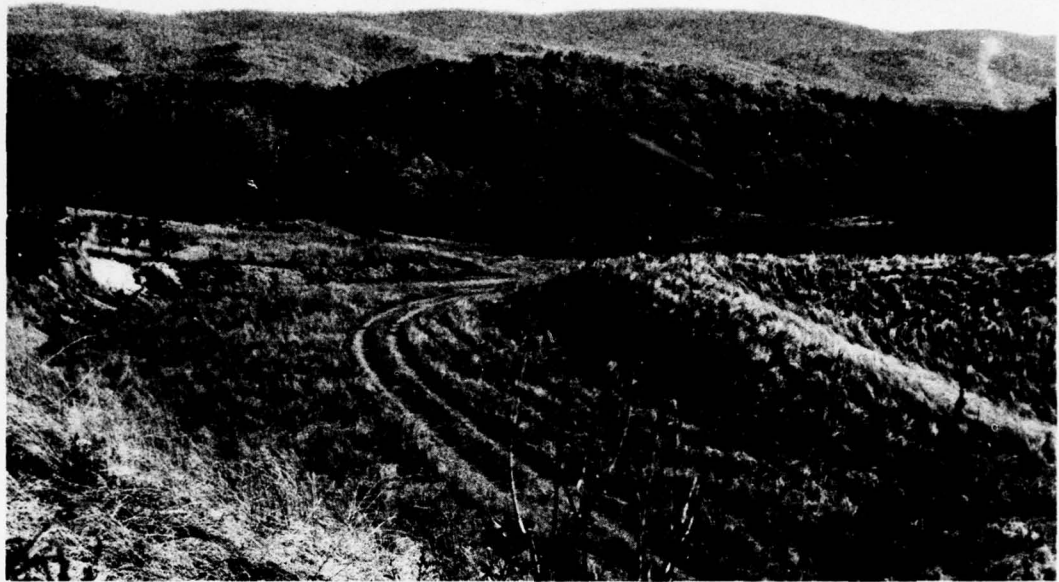
PHOTO 5. Upstream View of Emergency Spillway and Right Abutment

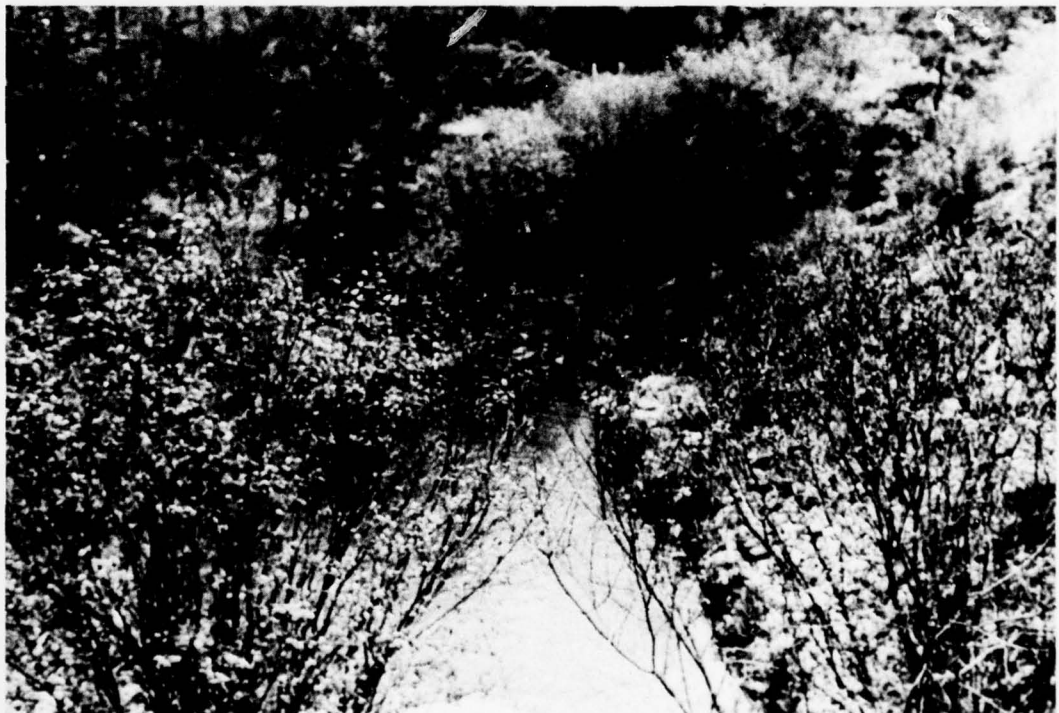
- 3.1.5 Downstream Channel: No riprap was provided in the downstream channel or stilling basin. However, there is no significant erosion and the slopes are stable; shale bedrock is exposed in the bottom of the channel near the outlet pipe. The slope of the disposal area for excess excavation to the right of the channel is steep, but no slumps were noted. At the time of inspection, the channel was unobstructed and the outlet pipe was in good condition. However, there are several small trees (approximately 2 inches in diameter) adjacent to the outlet pipe.

PHOTO 6. View of Downstream Channel Area
